## 4.3 EVALUATION BASED ON SURFACE APPERANCE

## **TYPES OF FLEXIBLE PAVEMENT FAILURES**

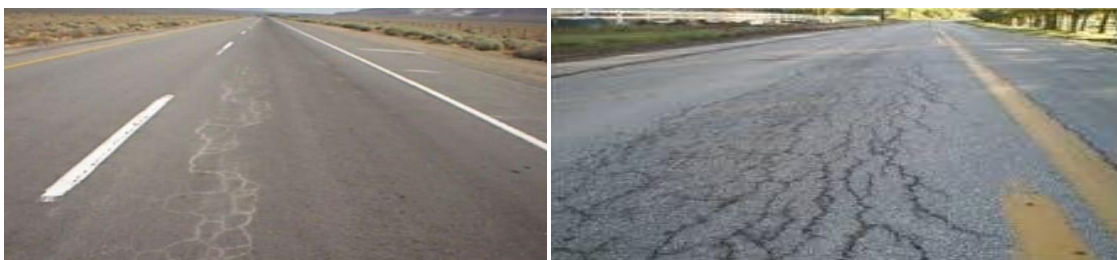
This is a common type of failure of flexible pavements. This is also known as fatigue failure. Followings are the primary causes of this type of failure.

- Relative movement of pavement layer material
- Repeated application of heavy wheel loads
- Swelling or shrinkage of subgrade or other layers due to moisture variation

*Alligators on Road surface*

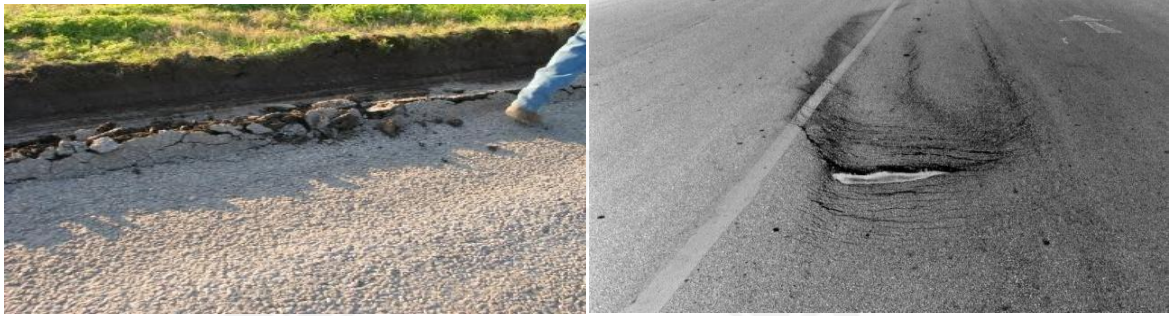
Shear failure causes upheaval of pavement material by forming a fracture or cracking. Followings are the primary causes of shear failure cracking.

- Excessive wheel loading
- Low shearing resistance of pavement mixture

*Shear Fail on Road Surface*

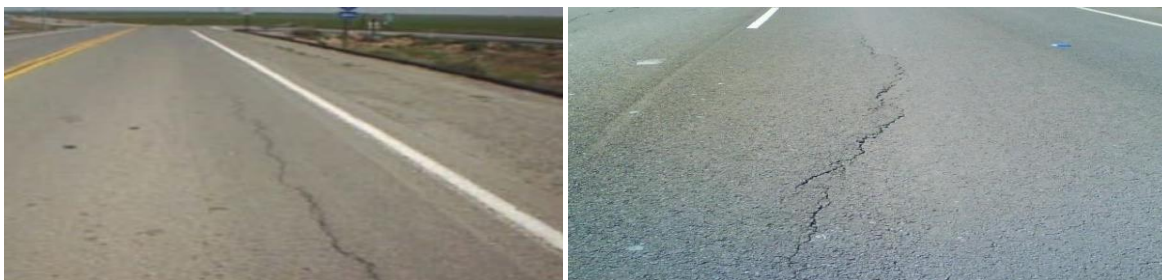
This types of cracks extents to the full thickness of pavement. The following are the primary causes of longitudinal cracking.

- Differential volume changes in subgrade soil
- Settlement of fill materials
- Sliding of side slopes

*Longitudinal Crack on Road Surface*

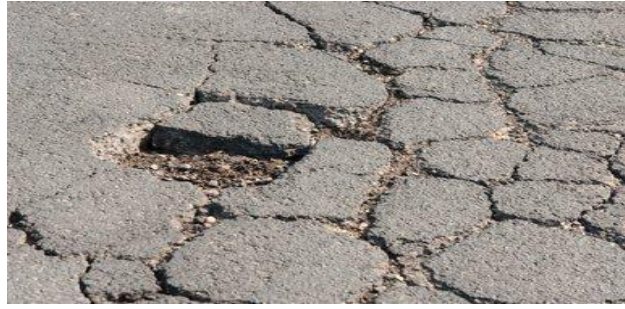
Frost heaving causes upheaval of localized portion of a pavement. The extent of frost heaving depends upon the ground water table and climatic condition.

*Frost Crack on Road Surface*

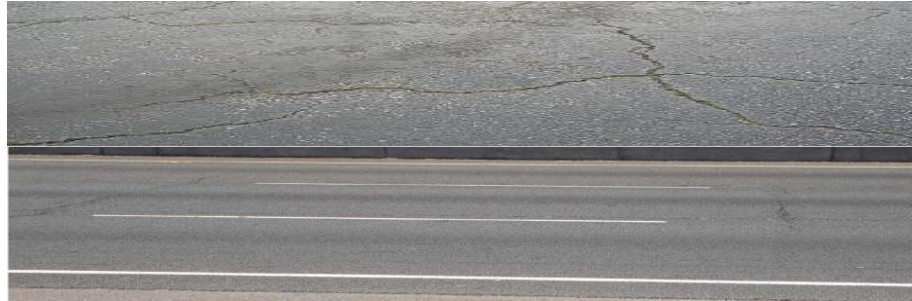
This type of failure occurs, when bituminous surface course is laid over the existing cement concrete pavement with some cracks. This crack is reflected in the same pattern on bituminous surface.

*Reflection Crack on Road Surface*

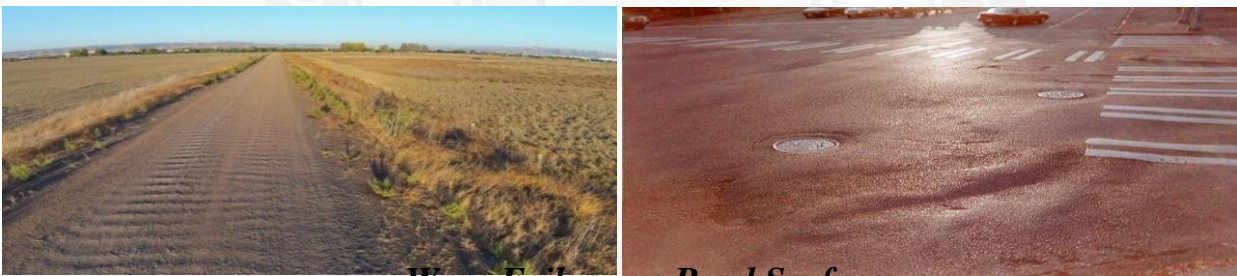
Transverse undulations appear at regular intervals due to the unstable surface course caused by stop- and-go traffic.

*Wave Failure on Road Surface*

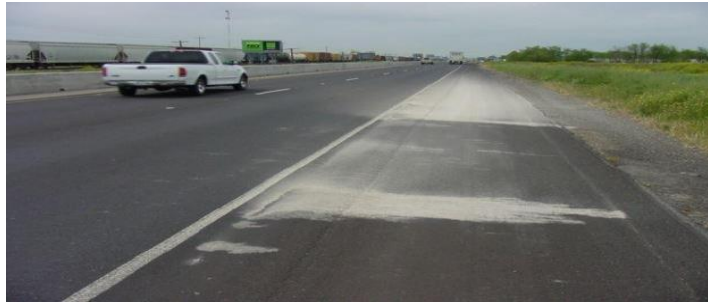
Seeping or ejection of water and fines from beneath the pavement through cracks is called pumping.

*Mud Pumping on Road Surface*

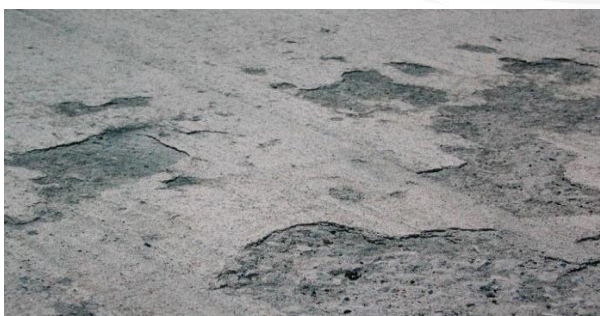
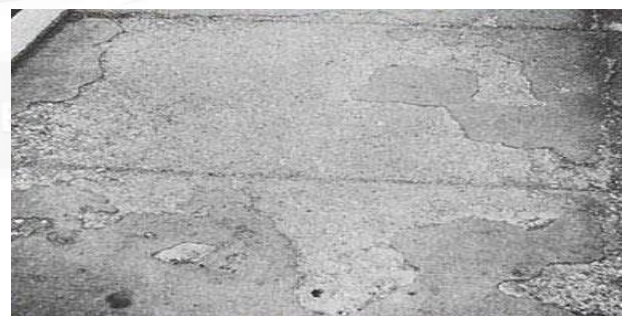
### **Shrinkage Crack on Road Surface (a)**

Formation of hairline shallow cracks on concrete slab is the indication of shrinkage cracks. Shrinkage cracks develop on concrete surface during the setting & curing operation. These cracks may form in longitudinal as well as in transverse direction.

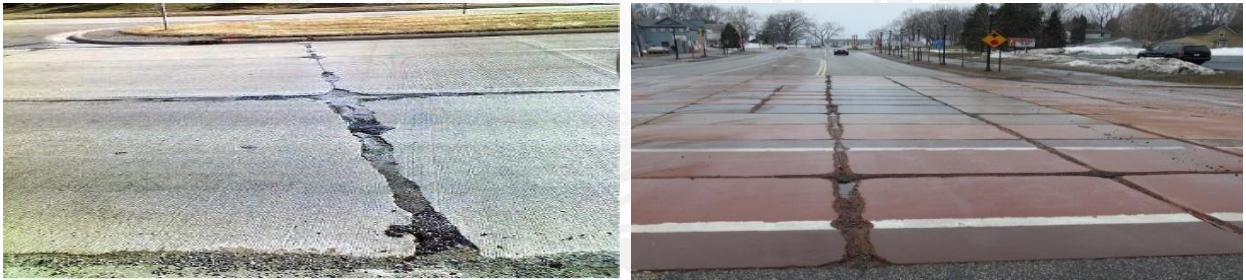
Joint spalling is the breakdown of the slab near edge of the joint. Normally it occurs within 0.5 m of the joints. The common reasons for this defect are

- Faulty alignment of incompressible material below concrete slab
- Insufficient strength of concrete slab near joints
- Freeze-thaw cycle
- Excessive stress at joint due to wheel load

***Joint Spalling Crack on Road Surface***

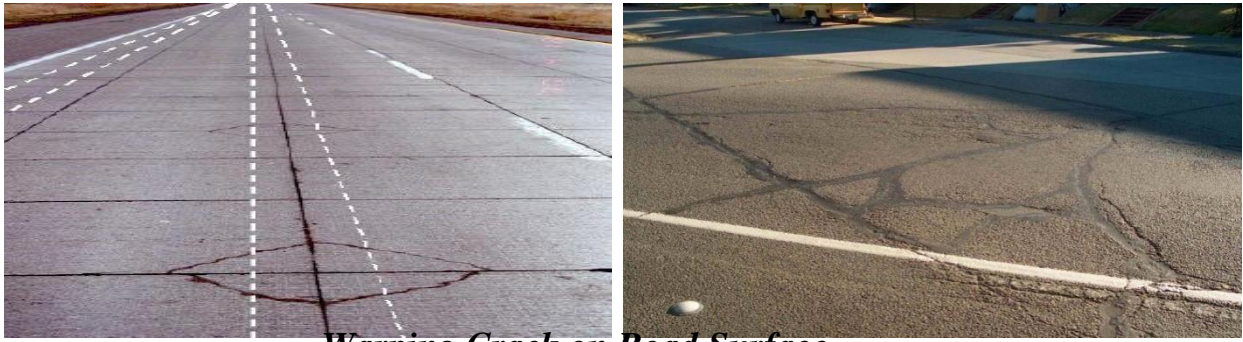
In hot weather, concrete slab tends to expand. Therefore the joints should be so designed to accommodate this expansion. When joints are not designed properly, it prevents expansion of concrete slab and therefore results in development of excessive stress. This stress cause formation of warping cracks of the concrete slab near the joint edge. This type of crack can be prevented by providing proper reinforcement at the longitudinal and transverse joints. Hinge joints are generally used to relieve the stress due to warping.

*Warping Crack on Road Surface*

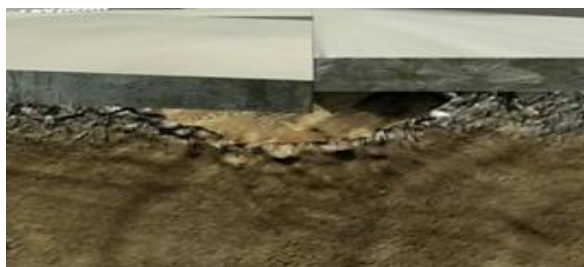
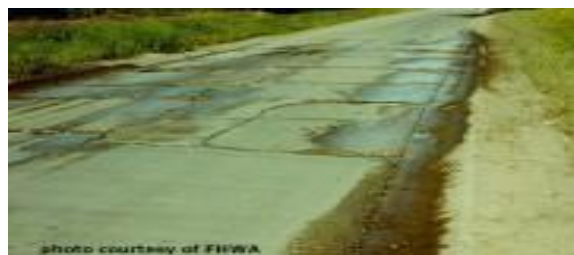
When material present below the road slab ejects out through the joints or cracks, it is called pumping. When soil slurry comes out it is called mud pumping.

- Infiltration of water through the joints, cracks or edge of the pavement forms soil slurry. Movement of heavy vehicles on pavement forces this soil slurry to come out causing mud pumping.
- When there is void space between slab and the underlying base of sub-grade layer
- Poor joint sealer allowing infiltration of water
- Repeated wheel loading causing erosion of underlying material

This type of defect can be identified when there is presence of base or sub-grade material on the pavement surface close to joints or cracks.

*Joint Soil Spillage on Road Surface*
