## 2.4 Concrete Flooring & floor finishes

### **Guide to Inspection & Diagnosis of Flooring Materials in buildings**

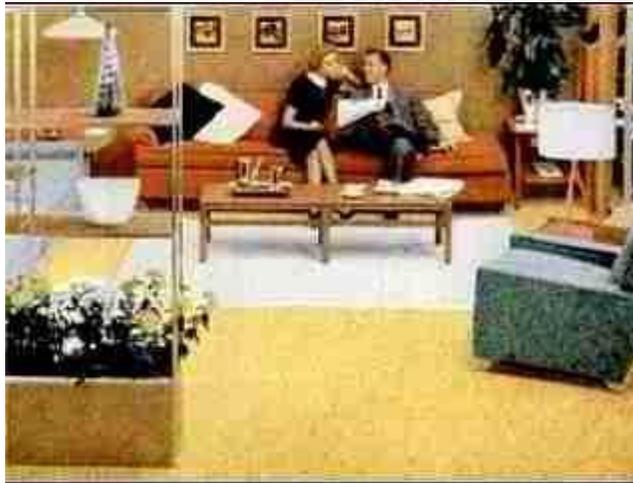
- LINOLEUM & Other Sheet Flooring shown at left, Congoleum sheet flooring also see Congoleum Flooring History

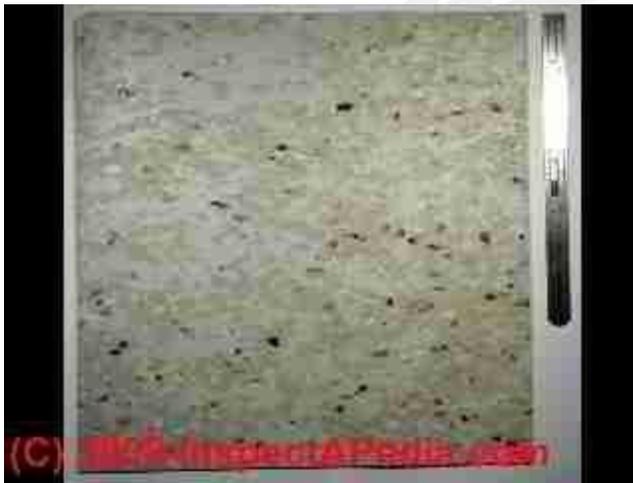
### **Vinyl Asbestos Floor Tiles - 1930 - 1976 (est)**

Vinyl floor tiles, including vinyl-asbestos floortiles and homogenous vinyl floor tiles (non-asbestos product) are almost as old as asphalt floor tiles. By the early 1950's in the U.S. vinyl tile floor products were more popular than asphalt-based flooring. The reason is pretty obvious.

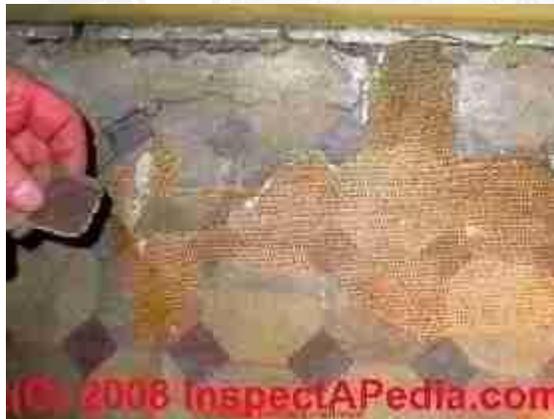
Here is a photograph of an early (pre-vinyl) continuous floor covering, 1900, in an 1840 historic Vermont house.

Note the fabric backing of the flooring material. This article explains various common flooring materials (rough wood, finished wood, parquet, carpeting, linocrusta, sheet

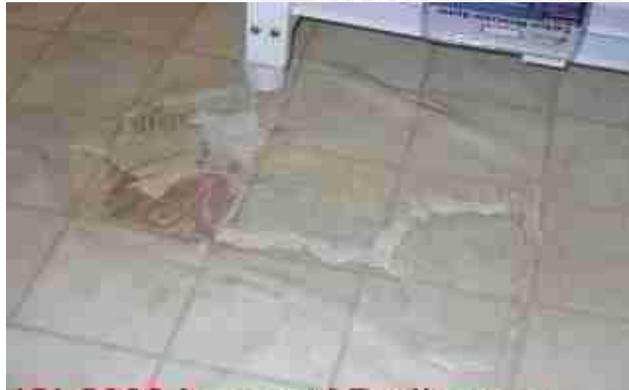
The resilient flooring product shown at left was made in the late 1990's and is not an asbestos concern, though in this case the flooring was damaged by water and movement of a cabinet.

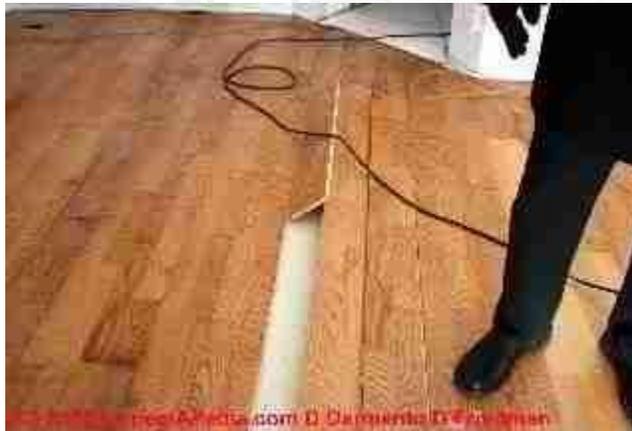
The laminate wood flooring shown at left was buckled and destroyed by flooding caused by a leaky heating pipe. As we discussed with traditional wood flooring above, severe flooding or installation errors can lead to total loss of the finish floor system.

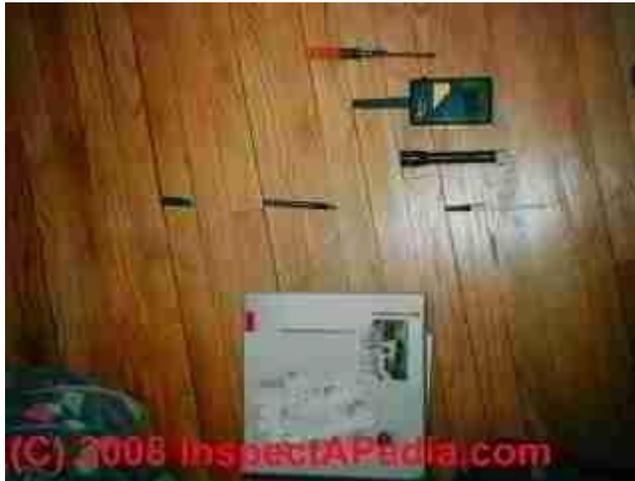
The gaps that appeared in the wood floor shown at left were caused by installation of the floor in a new home, over radiant heat tubing, and without allowing the flooring to reach a proper moisture level before it was nailed in place.

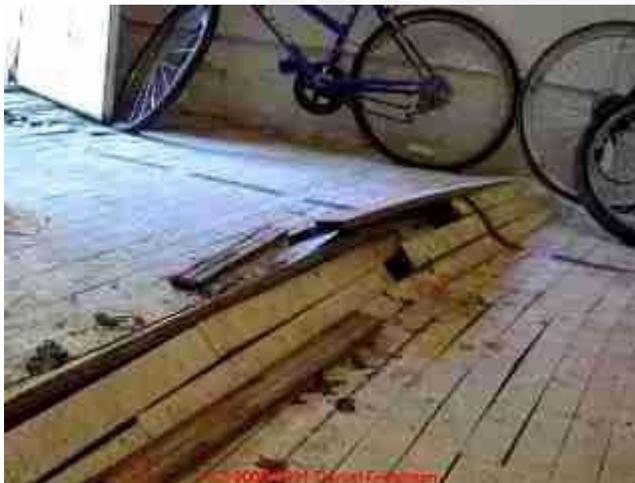
Extreme buckling can cause an upwards explosion of a wood floor when flooring is exposed to flooding or prolonged leaks.

This severe buckling wood floor damage can occur even at much smaller increases in interior moisture if a tongue and groove wood floor is improperly installed - leaving inadequate free space margin around the floor perimeter.
